**City of Fremont
California Nursery Historical Park**

**Volume 2: Tree Report &
Urban Forestry Management Plan**

Urban Forest Management Plan

California Nursery Historical Park
Fremont, CA

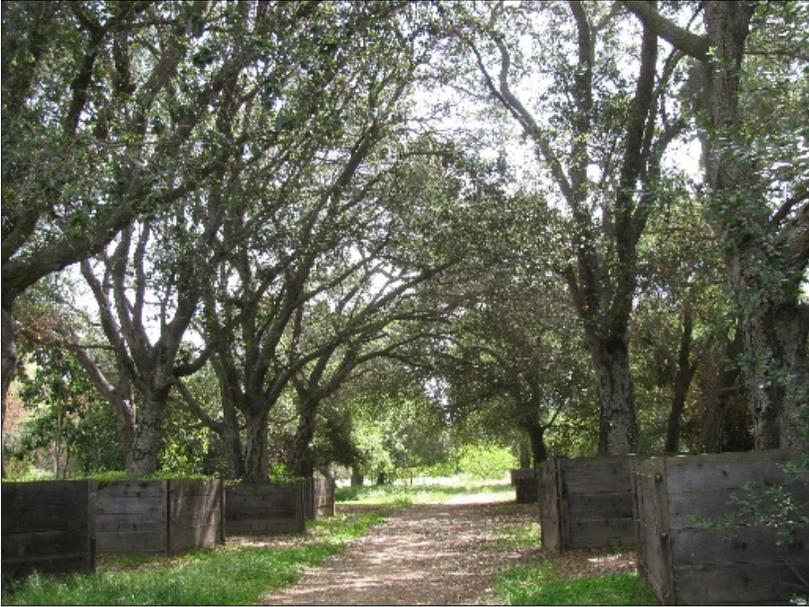
Photo 1. Trees to consider for Landmark status are the coast live oak boxed forest (left), California black walnut #247 (below), and bald cypress #257 (bottom left).

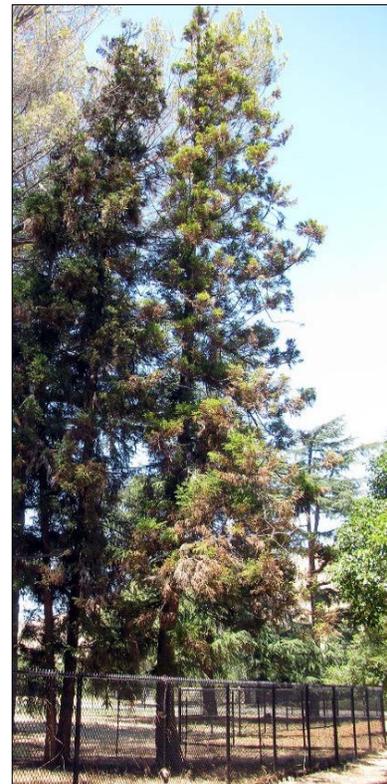
Photo 2. Japanese red cedar is an example of a declining tree scheduled to be removed in Phase 5 that could be considered for replacement planting.

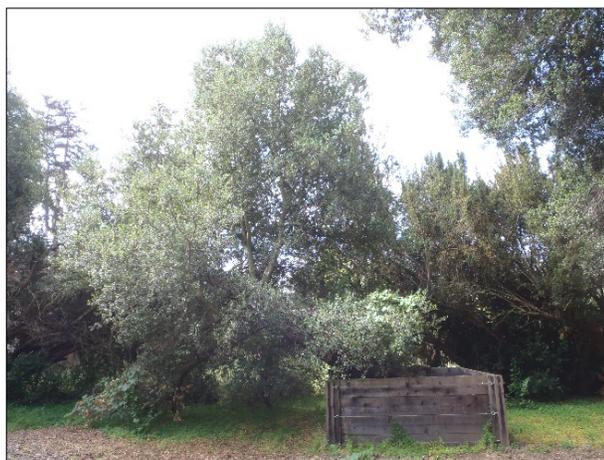
Photo 4. Coast live oak #621 has fallen so that the trunk is outside the box. A prop is needed to support the tree.

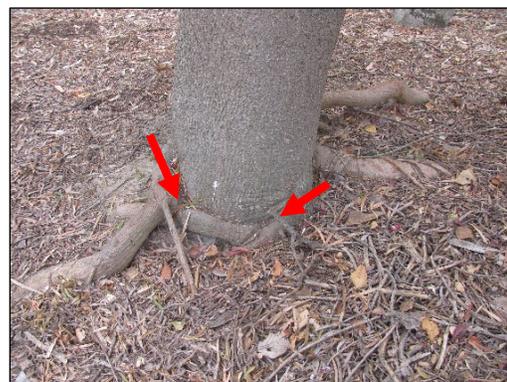
Photo 5. Remove the girdling root impacting tree #72.

One tree, a mature coast live oak #833 at the Roeding residence was being girdled by a chain wrapped around the trunk. The chain should be removed as soon as possible.

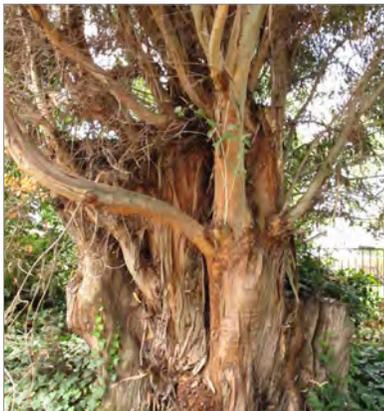
The trunk of this tree was cut in half and now has a gaping hole making it highly susceptible to disease and decay.

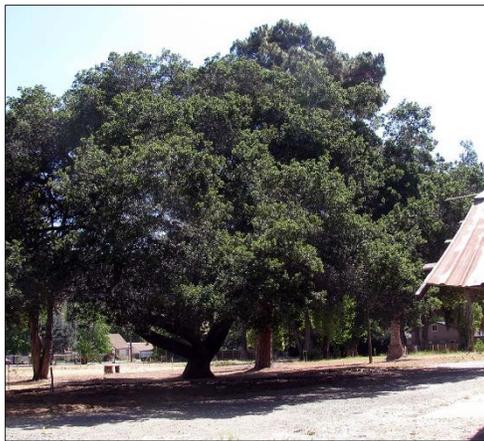
Photo 1: Drought tolerant coast live oak #250 (left) was green and healthy. In contrast, yew #571 (right) was brown and defoliating due to drought stress.

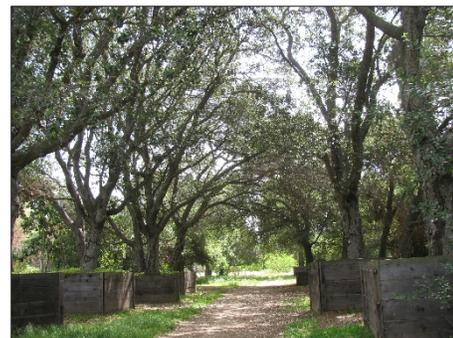
Photo 2: Coast live oaks planted in containers in the 1940's have rooted into the ground.

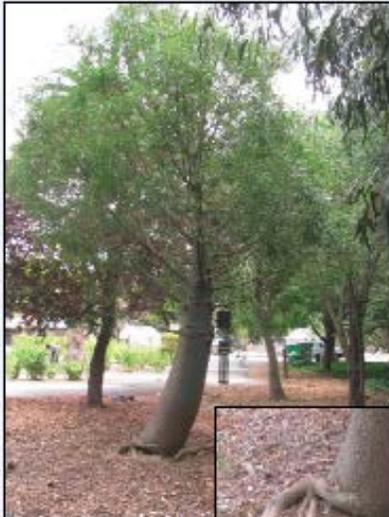
Queensland bottle tree #72 with girdling and kinked roots.

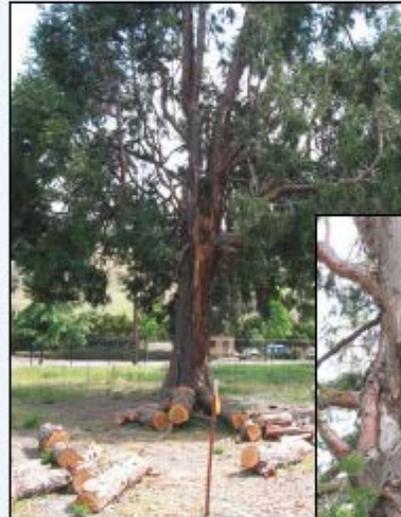
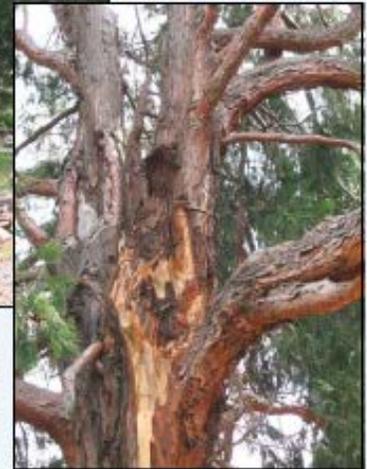
Incense cedar #211 had multiple branches arising at one point with weak attachments. Several branches have failed, one recently.

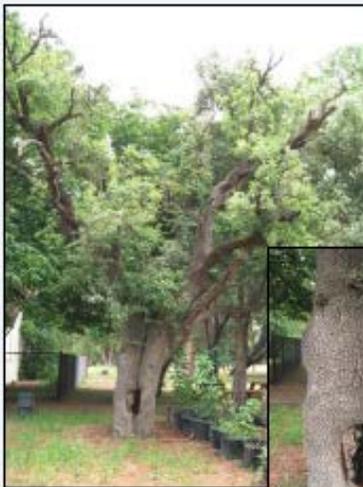
Mt. Atlas pistachio #244 is likely to fail due to extensive decay in the tower trunk at the attachment of two co-dominant stems.

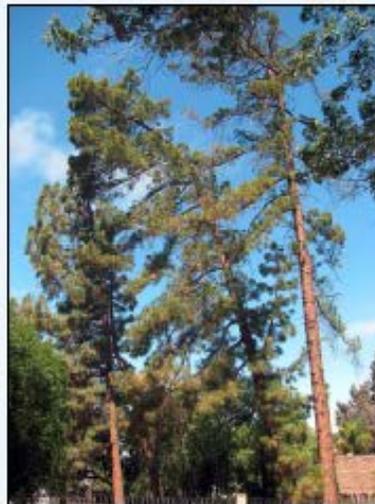
Canary Island pines #372 and 373 have dead branches and are leaning over use areas.

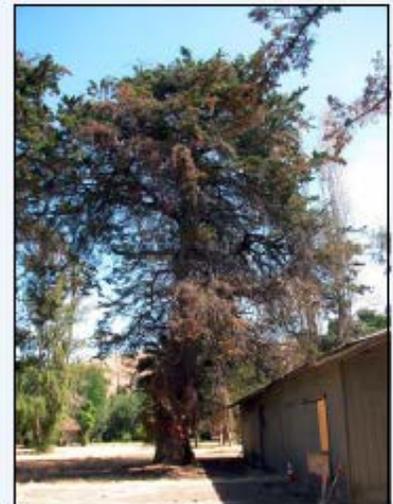
Monterey cypress #529 has dead and broken branches hanging over the building. Nearby cypress # 531, 535, and 540 also had significant defects. These are Landmark trees.

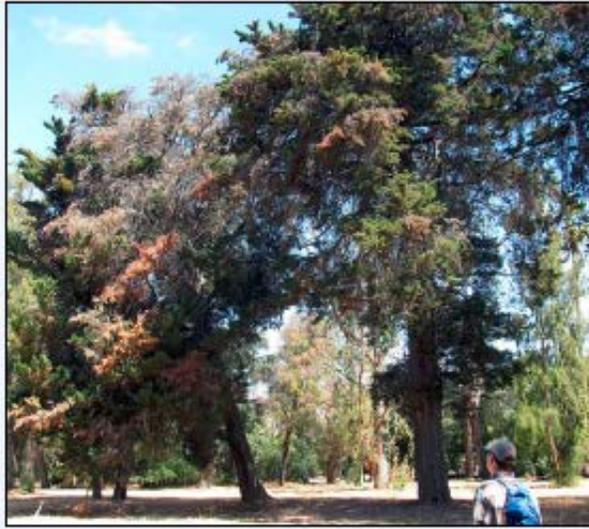
Monterey cypress #530, 531 were unfortunately in poor condition.

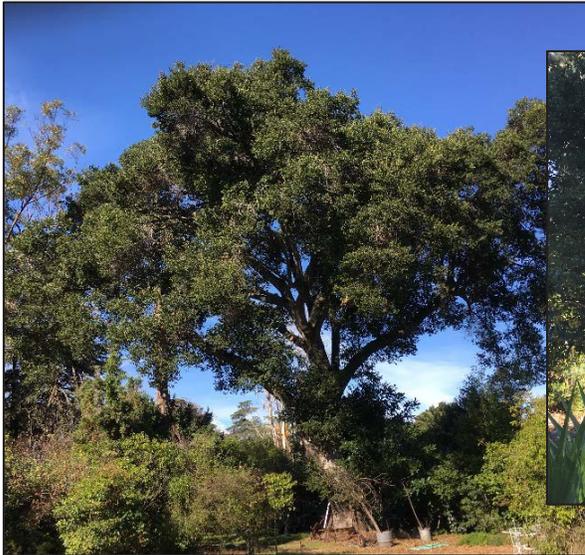
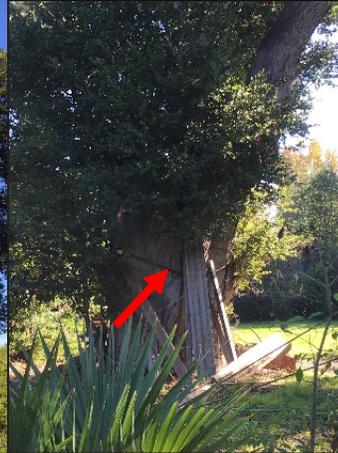
Photo 1. Coast live oak #833 was a 44" diameter tree in good condition. The chain that was girdling the trunk should be removed as soon as possible (arrow).

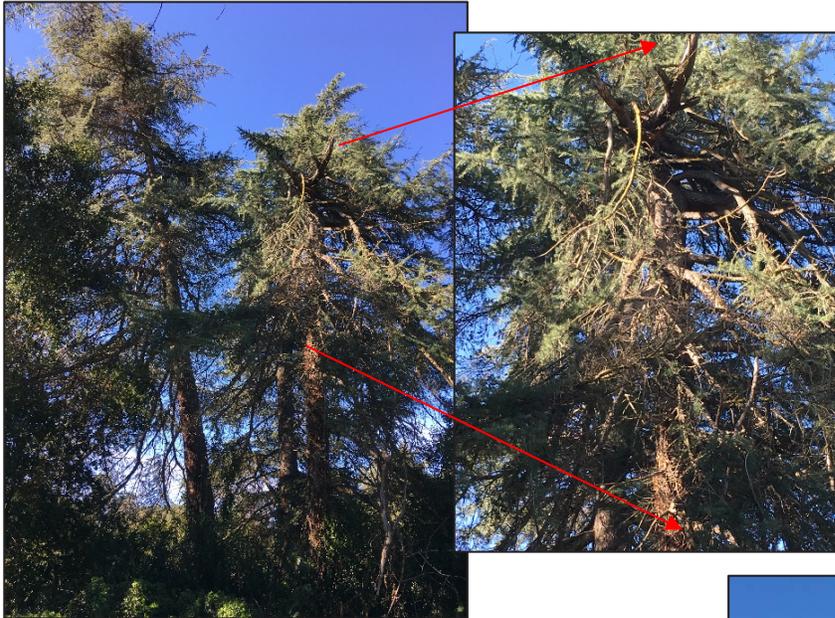
Photo 4. Mature deodar cedars #825-827 were in fair condition due to dieback, a history of branch failure and presence of broken and hanging branches. A close-up of broken branches in tree #827 is shown in inset.

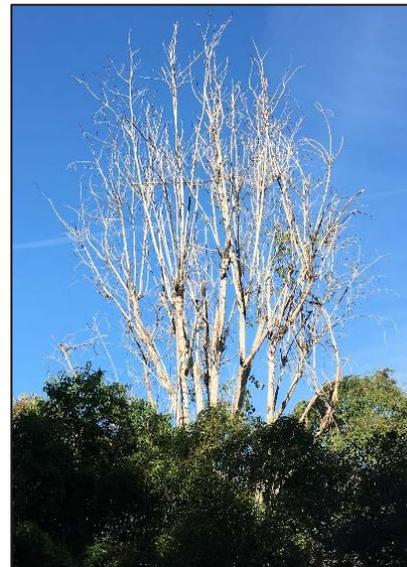
Photo 5. Fremont cottonwood #819 was almost dead.
