**City of Fremont
California Nursery Historical Park**

**Volume 2: Tree Report &
Urban Forestry Management Plan**

Urban Forest Management Plan

California Nursery Historical Park
Fremont, CA

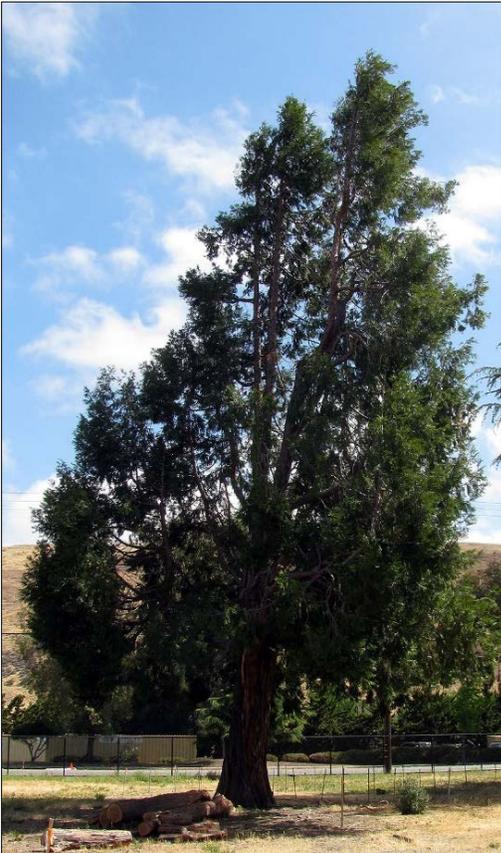
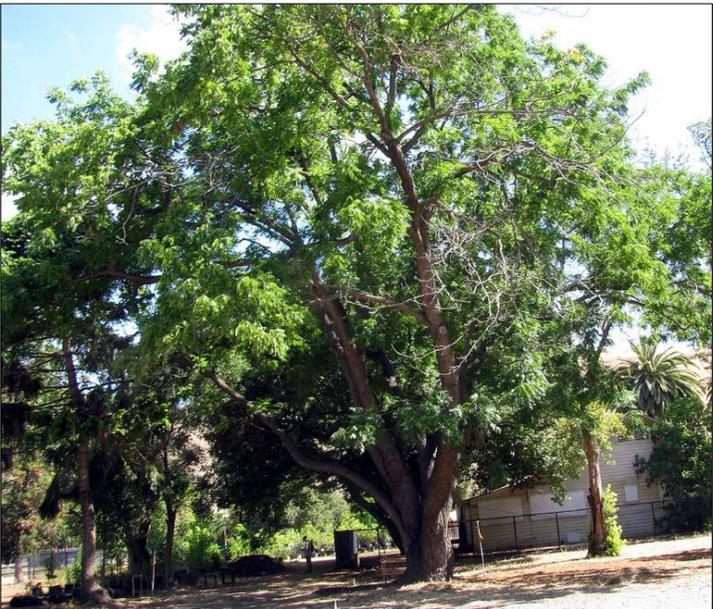
Photo 1. Trees to consider for Landmark status are the coast live oak boxed forest (left), California black walnut #247 (below), and bald cypress #257 (bottom left).

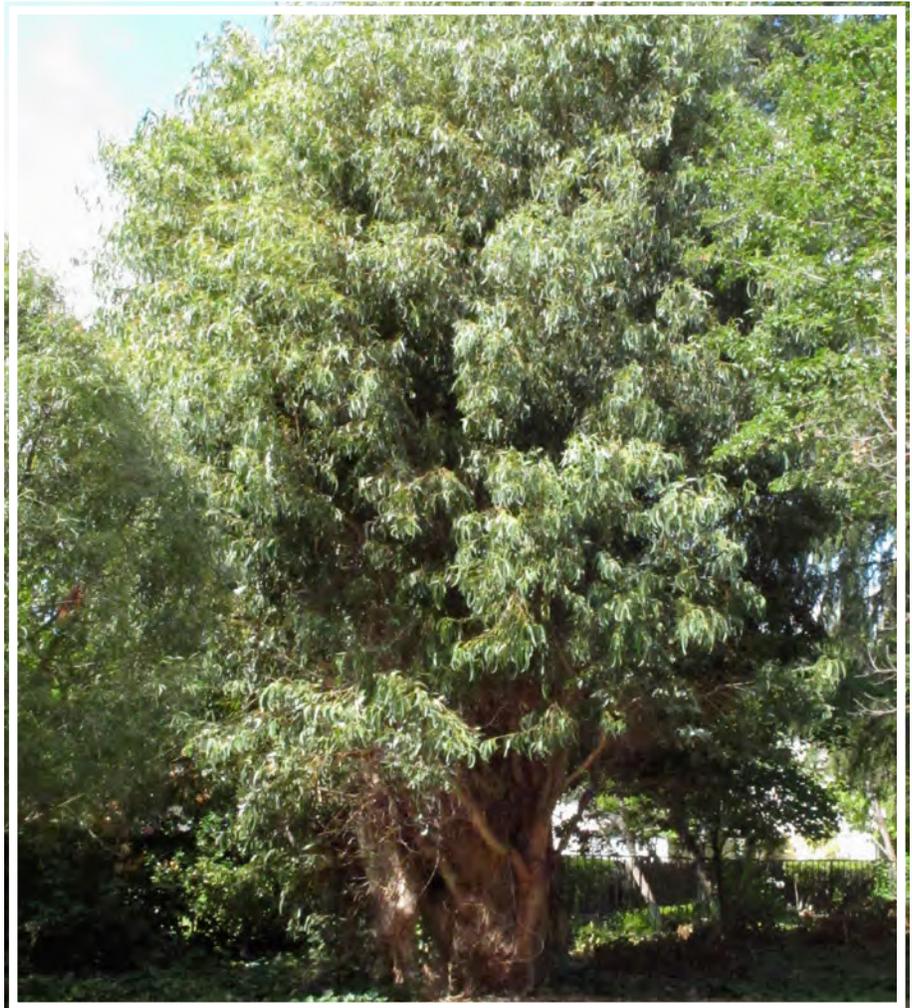
NIL-9 TREE INFORMATION/August 2010

The trunk of this tree was cut in half and now has a gaping hole making it highly susceptible to disease and decay.

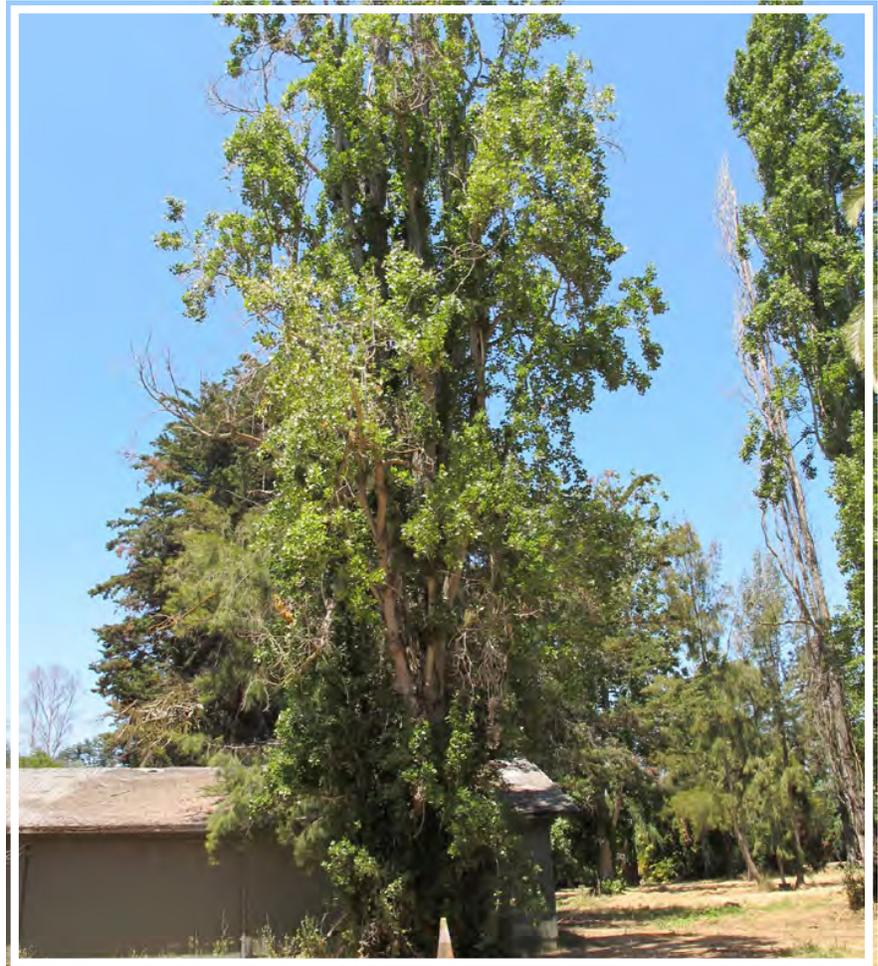
View of the canopy and numerous sprouts growing from the branches.

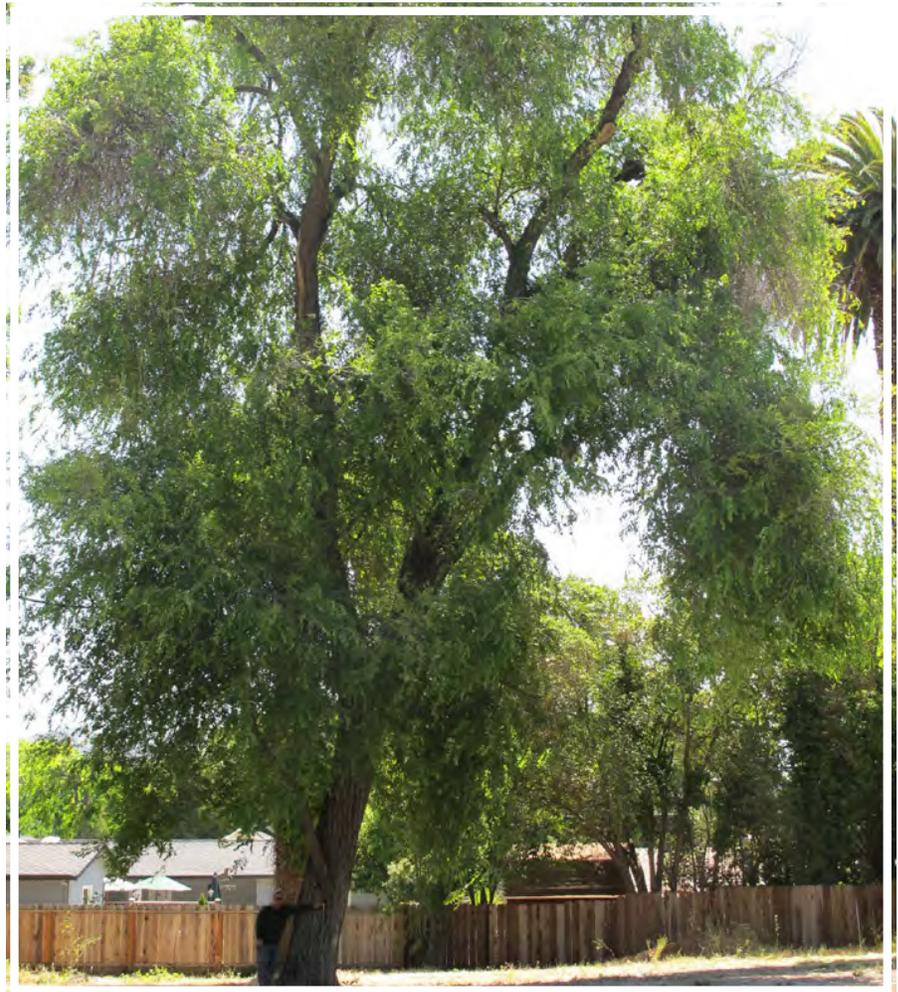
One of the three landmark Siberian Elms with a split-trunk.

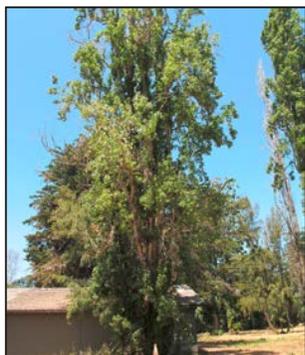
Photo 3: Landmark Lombardy poplar (left) died this summer, presumably from drought stress.

Landmark forest kurrajong (right) tree had died previously and was removed before our inventory.

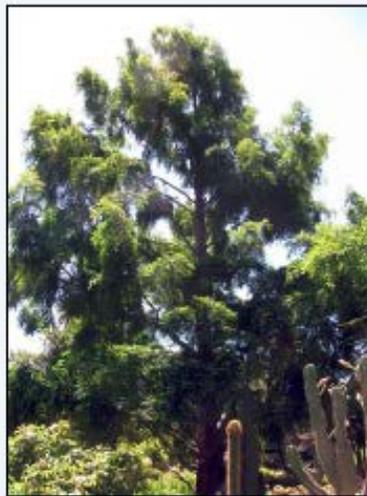
Dawn redwood #84. is an unusual species for the region.

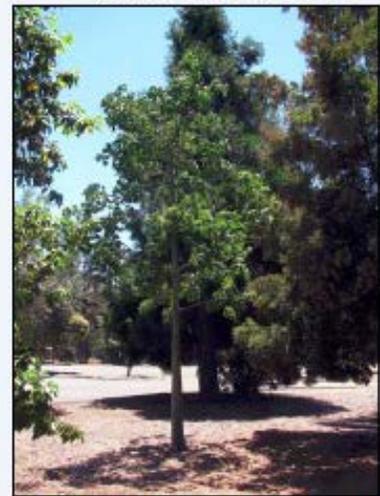
Floss silk tree #173 is an unusual species in the region.

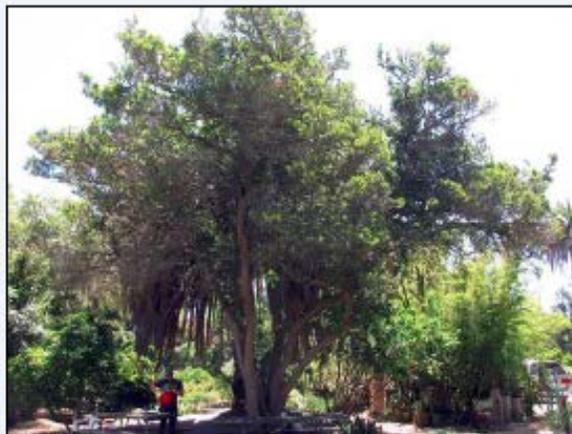
Cockspur hawthorn #77 is an unusually large specimen.

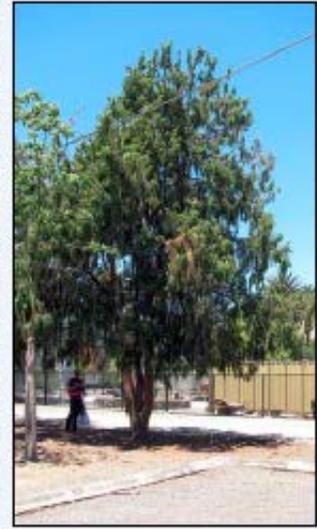
Canary Island juniper #174.

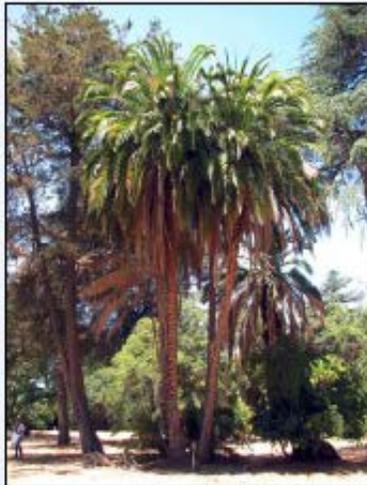
Sengal date palm #544.

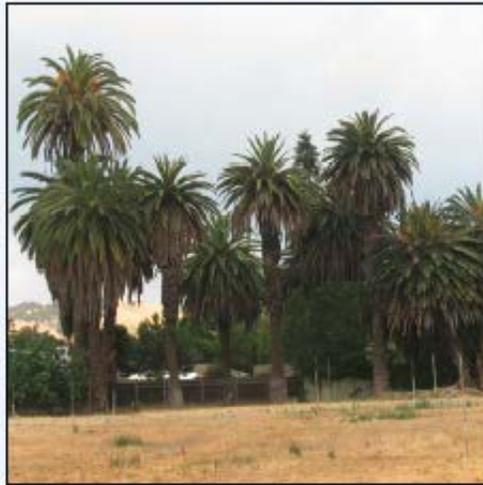
26 Canary Island date palms planted in the late 1880 to early 1900s.

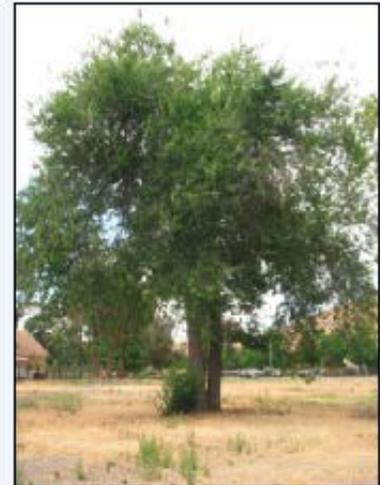
Siberian elm #307.

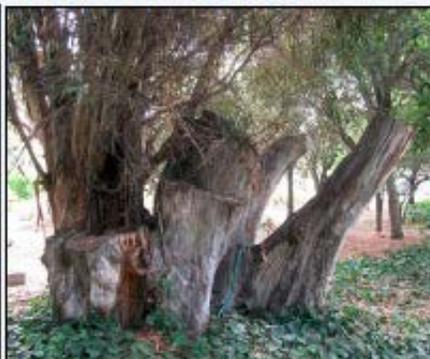
Dwarf blue gum #117; unfortunately most of the trunk was dead.

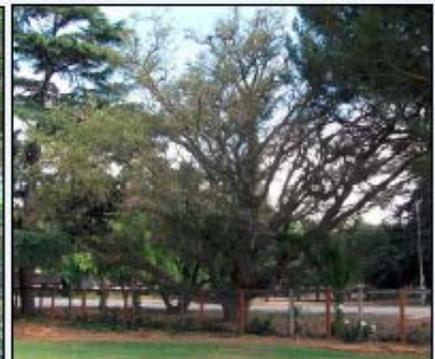
Cork oak #738 was in severe decline.

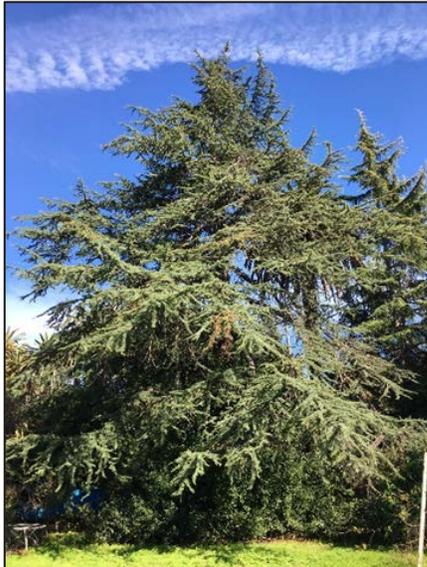
Photo 2. 43" diameter deodar cedar #852 was in good condition.

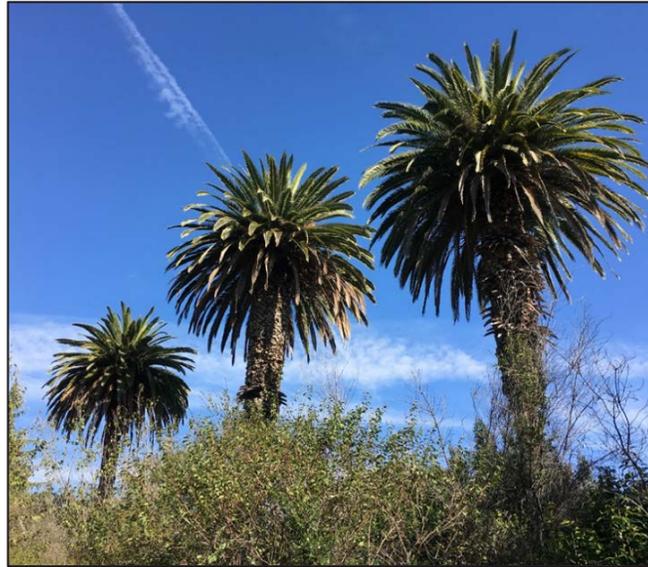
Photo 3. Canary Island date palms #857-859 were three of the six palms in good condition.
